MARINE INVESTIGATION REPORT
M99W0116

STRIKING

CANADIAN COAST GUARD HOVERCRAFT "SIYAY"
STEVESTON JETTY, SOUTH ARM OF THE FRASER RIVER,
BRITISH COLUMBIA
15 JULY 1999

Report Number M99W0116

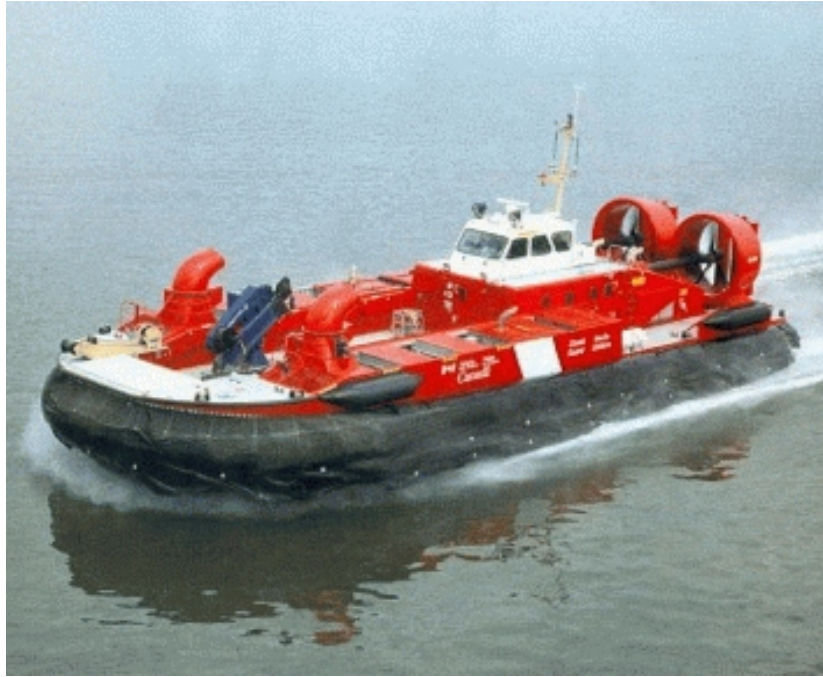
Figure 1. The “SIYAY”.

The control cabin of the "SIYAY", similar in design to that of an aircraft, is near the after end of the craft (see Figure 1). The design allows for an excellent view forward, with the exception of

the bow thruster vents to port and starboard at the forward end of the craft, which cause blind sectors. Operationally these blind sectors are overcome by the craft captain and port seat occupant exchanging information as targets move from one sector to the other.

- obstructed field of view from the control cabin, caused by the bow thruster vents;
- side windows were not inclined and therefore reflections were problematic at night;
- searchlights were designed for two-handed operation by someone other than the pilot (one hand is required to stabilize the unsecured control unit, while the other hand is needed to operate the joystick);
- some navigation equipment did not allow for individual control of illumination and lighting;
- night-time operation required relocation of navigator from fore to aft of the bridge, because the light from the radar reflected on the control cabin windows affecting the ability to see out of the windows and the crew's night vision;
- light from search beams reflected off the water spray from the bow of the craft,² thereby obscuring forward visibility from the bridge at night.

1. Ergonomic principles were not fully integrated into the design and acquisition process of the AP1-88/400 craft, resulting in blind spots created by the bow thruster vents which also affected use of the searchlights; high night-time illumination levels in the fore section of the control cabin; and night-time window reflections, which compromise the safe operation of the vessel.

1. control cabin windows have been reconfigured to reduce glare;
2. searchlight controls have been relocated;
3. bow thruster vents and the forward ramp have been painted black to reduce glare;
4. bow thruster controls have been relocated;
5. an additional searchlight has been installed on the bow to account for blind spots caused by thruster vents and to reduce glare;
6. the spray reduction skirt has been modified to enhance effectiveness;
7. the Service Entry Plan for training has been formalized and is strictly adhered to;
8. increased staffing has resulted in a sufficient complement of trained pilots and first officers to operate the "SIYAY"; and
9. the duty pilot will decide which hovercraft should be used for particular SAR missions.

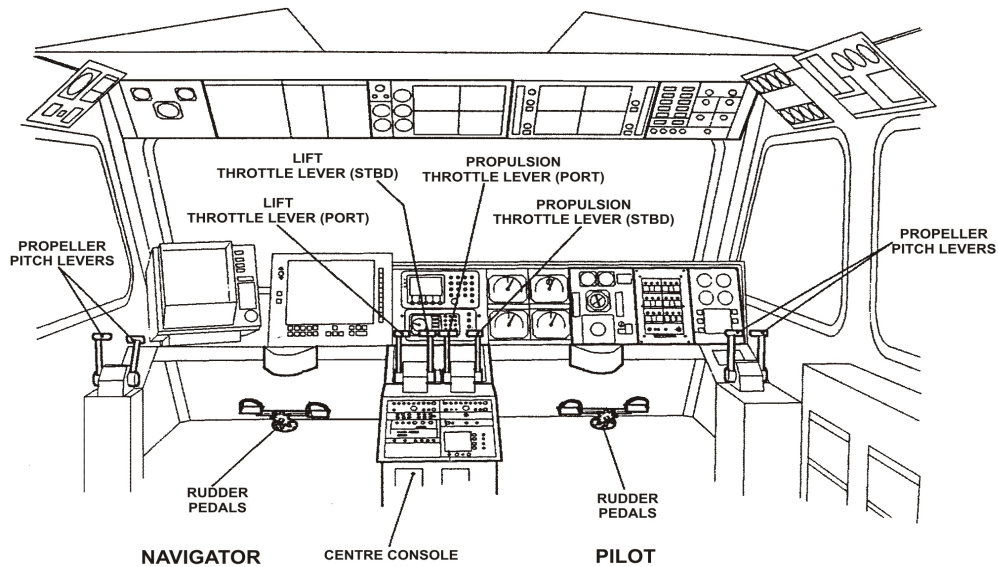
Figure 2. Instrumentation in the fore part of the AI1-88/400 control cabin.

The control cabin consists of four seats, two forward and two aft. Manoeuvring- and navigation-related instrumentation is arrayed across the fore part of the control cabin, below the windows (see Figure 2). Dual control levers for the propulsion system are in a centre console between the two forward seats. Dual controls for the bow thrusters are immediately in front of each forward seat. The very high frequency radios are on the centre console, and communication is via headsets. Navigation instrumentation consists of a radar, gyro, global positioning system, and depth finder. An additional radar is in the after part of the control cabin in a position accessible to the port side seat occupant.

The SRN-6 searchlight was designed to be used by the pilot. In contrast, the design of the AP1-88/400 searchlight calls for operation by someone other than the pilot. Standard procedures for operating searchlights had not been implemented, and the craft captain of the "SIYAY" was attempting to operate the starboard searchlight and pilot the craft in demanding conditions.

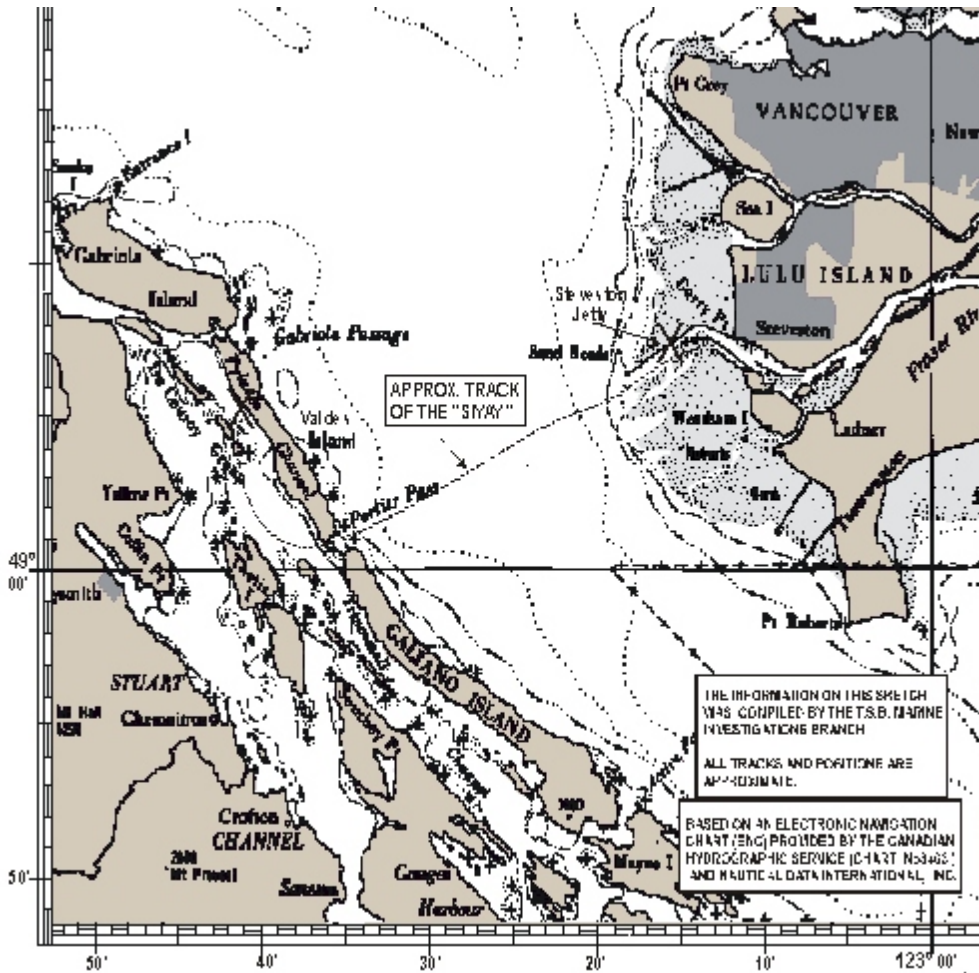
Appendix A - Sketch of the Occurrence Area

The crew located a gap in the jetty using radar, lined up the craft with the aid of light buoy No. S6, and then proceeded toward the gap on a visual approach. The pilot was operating the starboard searchlight, maintaining focus on the east end of the gap, while the lookout used the port searchlight to maintain reference to the west side of the gap. As the craft captain approached the gap, he lost visual reference to the east side, and consequently became

concerned about where the craft was in relation to the gap. The craft captain attempted to rotate his searchlight to illuminate the west side of the gap, but in doing so, the searchlight lit up the bow thruster vents, making visual reference even more difficult. At this point,, the craft captain reduced speed and attempted to steer using the compass. The reduced speed resulted in greater spray, which created a large amount of visual clutter because it was illuminated by the searchlight. The poor visibility made attempts at reestablishing visual contact with the gap even more difficult. The crew reported feeling the craft move sideways as the bow passed through the gap, immediately followed by the port side of the craft contacting the west side of the jetty. Time of contact was estimated to be 0019, on 15 July 1999. The craft returned to base unassisted.

Steveston Jetty has several gaps in it through which a cross current flows and on ebb tides extremely turbulent water exists in the vicinity of the rock groyne at Steveston Bend.

1. While attempting to navigate through a gap in the Steveston Jetty, the “SIYAY” contacted the breakwater because the craft captain lost visual reference to the sides of the gap.
2. The pilot’s forward visibility was obscured by the bow thrusters and the reflection of the searchlight on the water spray.
